MEADOW GROUNDS DAM,

(NDS LD. <sup>Number</sup> PA - 00185,

Potomac River Basin, Roaring  
Run, Fulton County, Pennsylvania

PHASE I INSPECTION REPORT.  
NATIONAL DAM INSPECTION PROGRAM

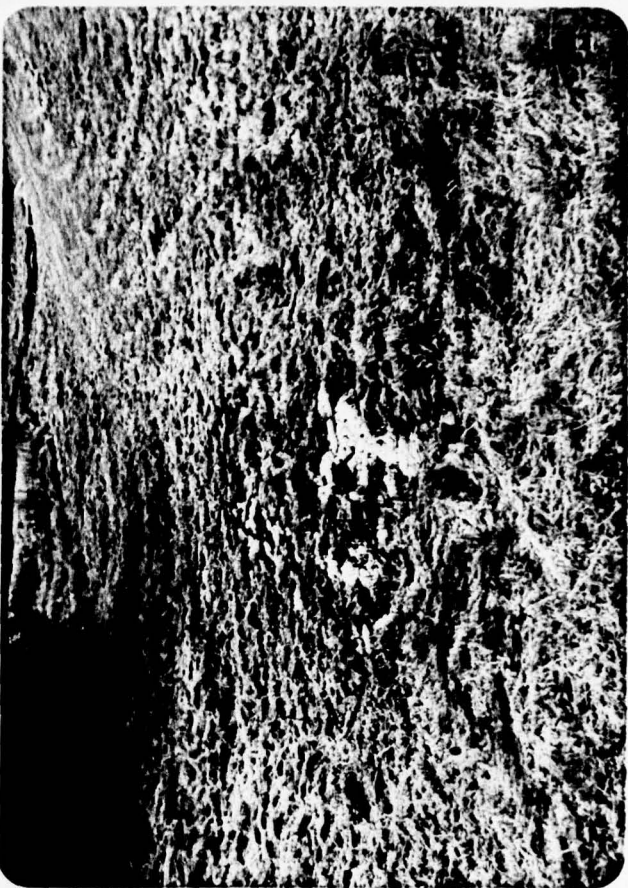
a. Embankment. Based on observations made during the visual inspection, the embankment is considered to be in good condition. The facility is well maintained and no evidence of sloughing, erosion or excessive settlement was observed. Seepage and swamp-like conditions, however, exist immediately downstream of the embankment toe, particularly along the left abutment.

Seepage became apparent during reservoir filling and a remedial drain was installed although its performance appears questionable. The seepage is presently not considered a threat to the structural stability of the embankment; nevertheless, the seepage and drainage conditions observed should be evaluated and remedial measures taken to effectively collect and discharge the resulting flow from the embankment area. Seepage close to the embankment-abutment contact should be specifically addressed in future inspections to determine if it is encroaching onto the embankment. If so, appropriate remedial measures should be undertaken.

PHOTOGRAPH 4 View of seepage emanating along left abutment-embankment contact.

b. Accurately map the seepage locations at the embankment-abutment contact and immediately downstream of the embankment and design an effective drainage system to eliminate observed ponding and swamp-like conditions.

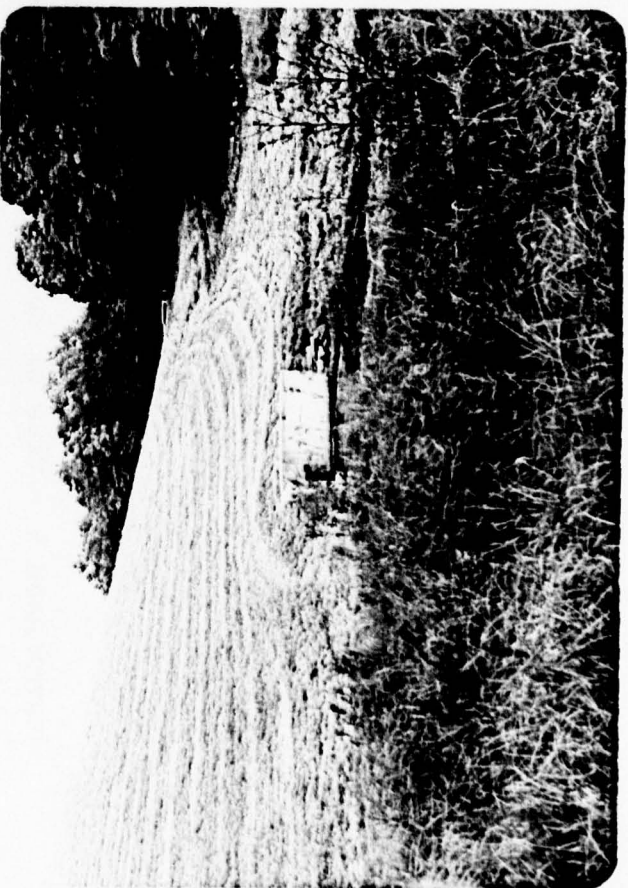
PHOTOGRAPH 3 View of left abutment-embankment contact and downstream slope.

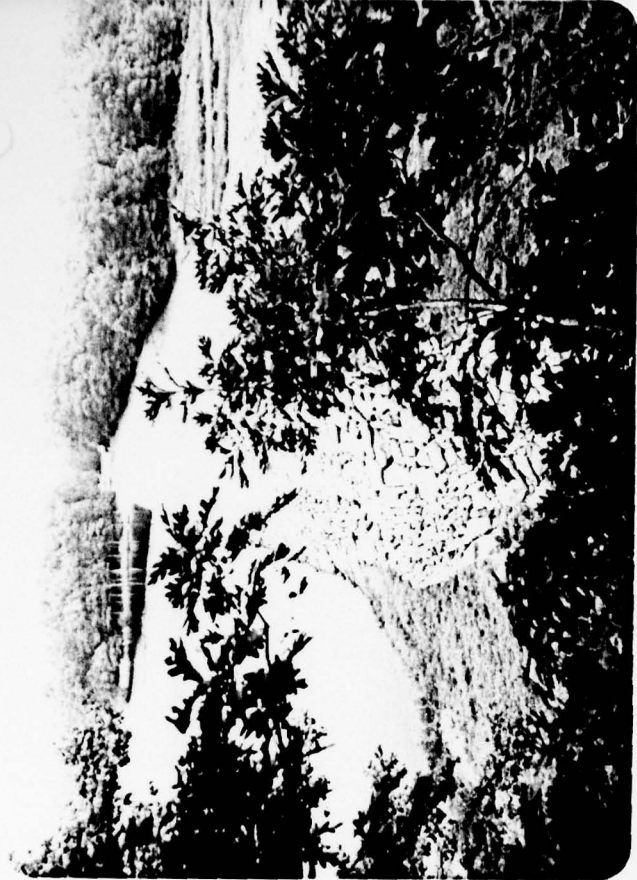
2

b. Embankment. Field observations indicate the embankment is well maintained (see Photograph 2) and in good condition. Significant seepage and swamp-like conditions are evident, however, immediately downstream of the embankment toe, particularly along the left abutment (see Photographs 3, 4, and 12). A remedial drainage trench was installed along the left abutment shortly after reservoir filling, but is apparently ineffective. Apparent poor drainage conditions (possibly from beaver dams along the outlet discharge channel) have resulted in ponding and difficult maintenance conditions.

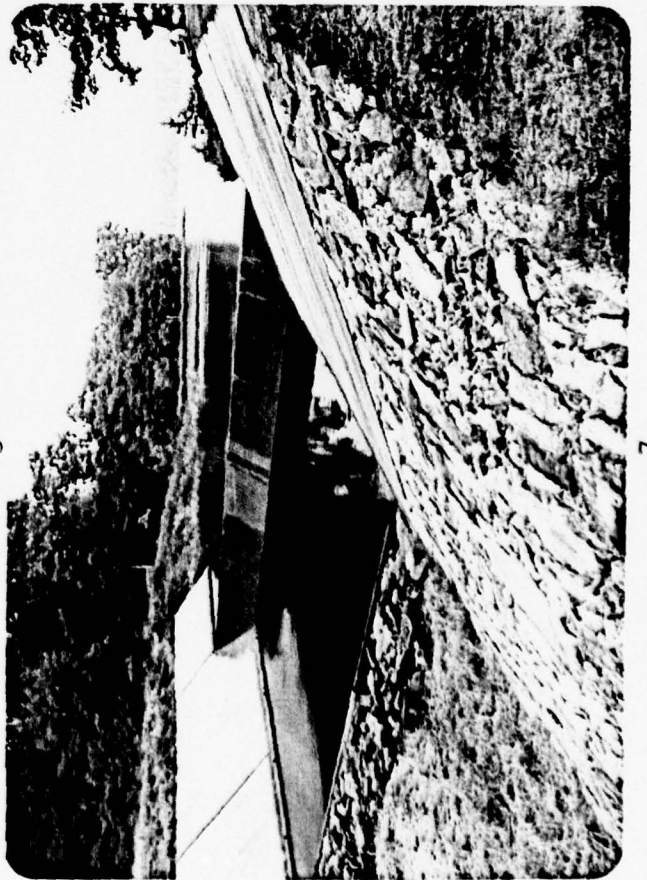
1. Spillway. Visual inspection revealed the spillway to be in good condition (see Photographs 6 and 7). No obstructions or concrete deterioration were observed. The channel immediately downstream of the stilling basin is adequately protected by hand-placed and/or dumped rock riprap (see Photograph 8).

PHOTOGRAPH 7 View of spillway from downstream, left channel wall.

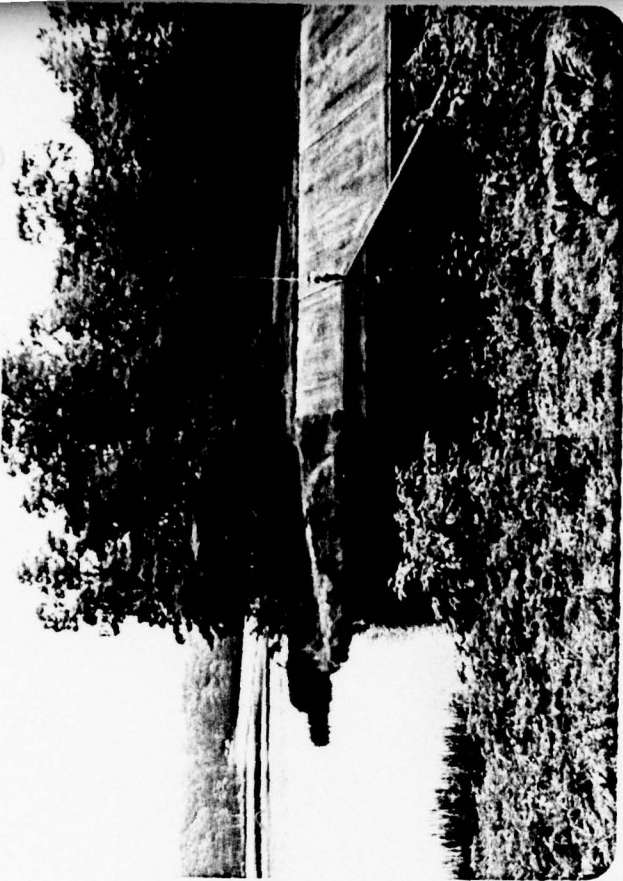
PHOTOGRAPH 5 View showing upstream slope (left of center) and spillway (extreme right).

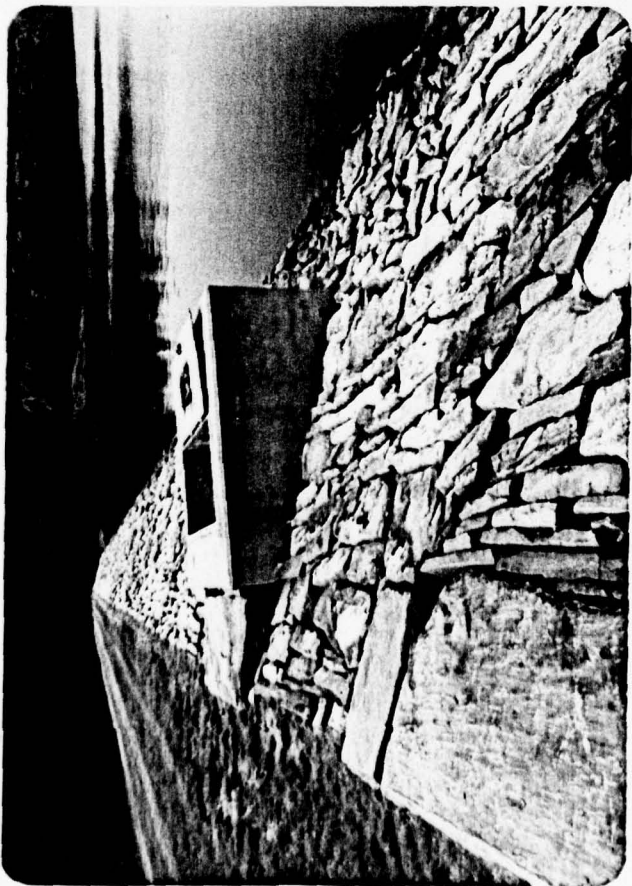
2. Outlet Works. Visible portions of the outlet works were found to be in good condition (see Photographs 9, 10, and 11). No concrete deterioration was noted on the control riser or outlet endwall. The interior of the outlet conduit was not inspected because of partial inundation and noxious conditions attributed to the stagnant pool at the outlet (see Photograph 11). The stoplogs were in place and functioning as designed.

PHOTOGRAPH 9 View showing top of control riser and hand-placed riprap.

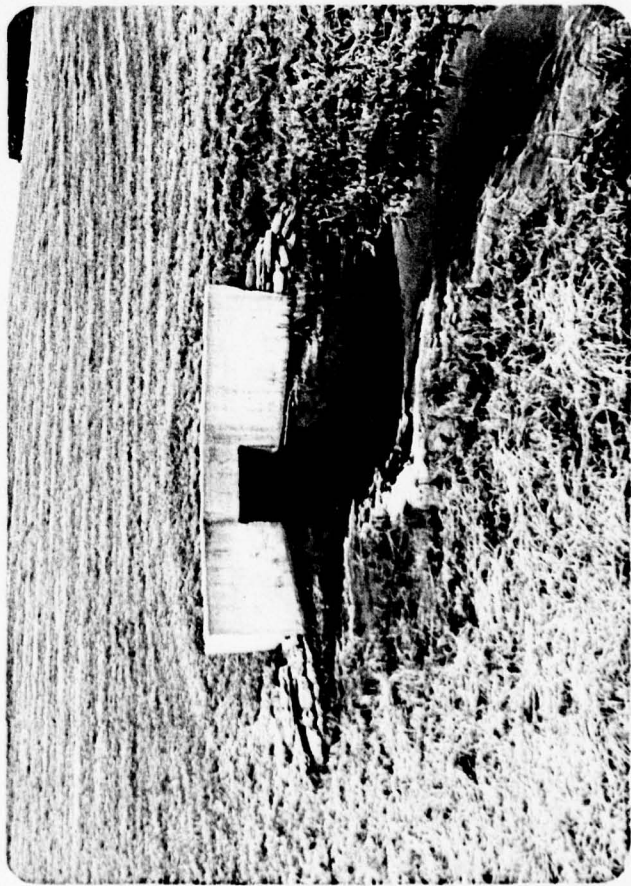
2. Outlet Works. Visible portions of the intake tower and outlet conduit were found to be in good condition. The outlet conduit was not entered due to partial inundation and noxious conditions attributed to stagnant water ponded at the outlet.

PHOTOGRAPH 11 View of outlet endwall and stagnant pool.

a. Evaluate the outlet works channel and take necessary remedial measures to provide unimpeded discharge through the channel.
